# Riparian-Wetland Soils

Technical Reference 1737-19

U.S. Department of the Interior • Bureau of Land Management

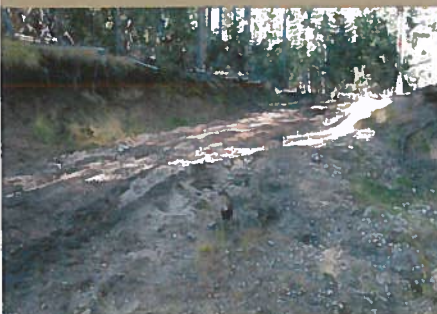
Figure 51. A hypothetical example from a road management plan.

#### INADEQUATE SURFACE DRAINAGE

Road X, milepost XX - located in the XXX section of the project area. Water has been running directly down the 10-percent-grade road. Previous maintenance efforts to smooth out ruts have left the road slightly below grade, encouraging surface water runoff to concentrate into erosion channels and deliver sediments to the adjacent riparian area. The road, as originally located, will continue to suffer needless erosion and rutting. Any future maintenance efforts to smooth the rutted road surface will only tend to lower the road further below grade, causing increased erosion problems, new ruts, and increased sediment input to the adjacent riparian area.

The solution proposed for this situation is to relocate the existing downslope road so that it contours around the hillside at a gentle 2 to 3 percent grade.

The relocated road has adequate grade changes to divert water off of the surface. The 4 to 6 percent outslope of the new road prevents water from accumulating. There should no longer be a need for annual maintenance to smooth out the irregular ruts that develop during rain events. The original road would heal more quickly if rehabilitated and converted back to productive pasture. The relocated road was constructed with a medium-sized loader scraper in about 3 hours at a cost of \$200.

- A reduction in sediment entering waters where current road conditions pose a high risk of sediment delivery.
- The potential to reduce sediment entering streams, allow for a higher level of road maintenance, and reduce long-term road management costs through the more efficient allocation of limited resources for road repairs and maintenance.
- The opportunity to develop a road management model for public land with local, regional, and national implications and to provide continuing education for landowners and operators specific to road construction and maintenance practices.
- A systematic means for remedying road problems (Figure 51).

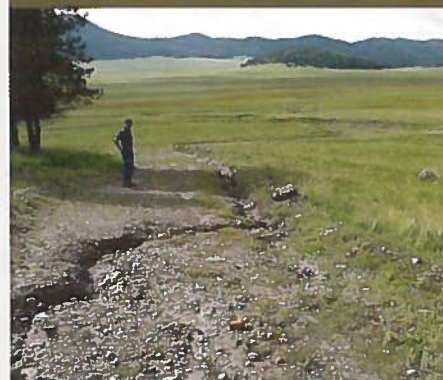
Figure 50. Without maintenance and proper management, roads will continue to degrade and supply sediment to adjacent riparian areas.

Within the 89,000-acre area, there are approximately 1,000 miles of roads, of which 100 miles have been surveyed. The watershed condition assessment validated the need for a full road assessment within the management site. A comprehensive road plan would establish what roads are needed. The road management plan on the adjoining national forest is a good example to follow and would provide long-term management guidelines for open roads and recommendations for temporary and permanent road closures. Defining a base road network should be the first step in managing roads within the area (Figure 50).

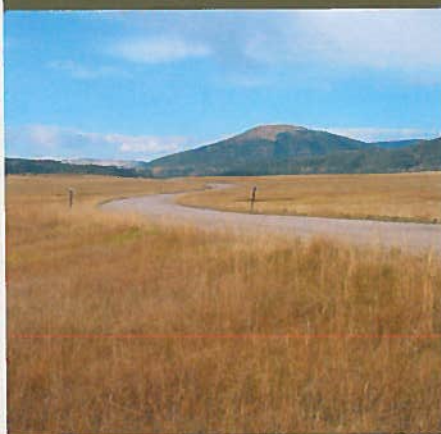
Figure 47. Road following old, established wagon route.

Early roads followed old established routes along stream bottoms, where construction was easier and less expensive (Figure 47). Drainage structures and maintenance practices were designed to move water away from the road to keep the travelway's surface and subsurface dry. Infrequent drainage structures, augmented with extensive ditch networks, were preferred over numerous small structures to save effort and expense. Maintenance practices commonly routed water and sediments from the road surface and ditches directly into stream courses for rapid removal. This benefited the transportation system, but commonly caused unintentional harm to other resources by fostering extensive road surface erosion, sediment transport and deposition, and erosion of riparian areas.

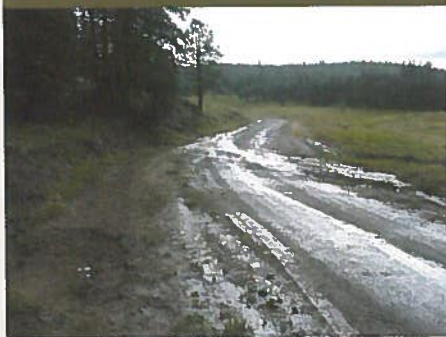
Figure 48. Inadequate surface drainage is a common problem across the area.

Over time, riparian areas in poor condition became a common sight and people grew to accept these conditions as normal. Land managers, whose livelihoods were most directly affected by riparian losses, recognized problems, spurring on-the-ground improvements. Many well-designed roads are evidence of this. Unfortunately, there are also problems associated with the roads that can be observed today (Figure 48).
