Riparian Restoration on Farms and Ranches in Texas

Introduction

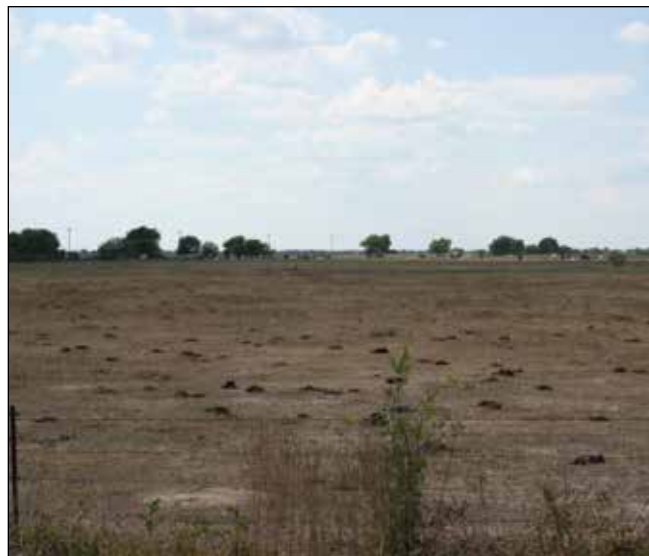
Figure 3. Overgrazing in upland areas leads to less infiltration and greater runoff and erosion. Photo by Mark Tyson, Texas A&M AgriLife Extension Service.

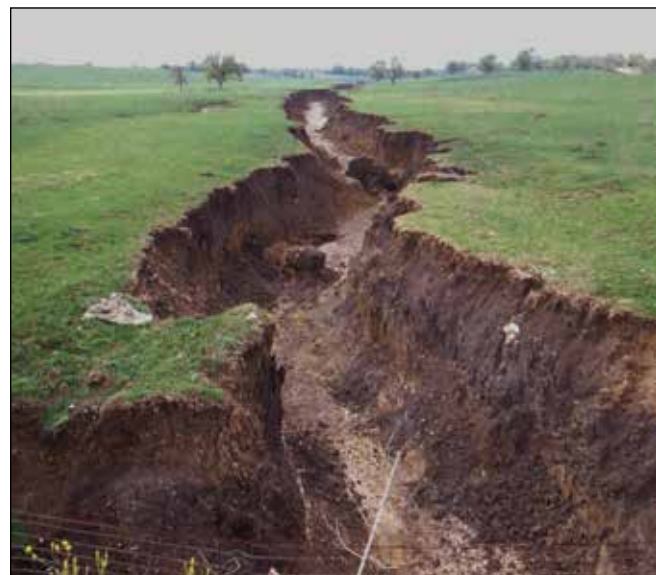
Figure 5. Poor riparian management has led to extreme downcutting in this creek. For reference, the block of soil closest to the camera is the size of a refrigerator. Photo by Kenneth Mayben, Natural Resources Conservation Service.

contributed in a watershed (Figure 5; Wynn and Mostaghimi, 2006). The Texas Water Development Board (2009) calculated that the Richland-Chambers Reservoir in Navarro County loses 2,065 acre-feet of water capacity every year for a total loss of 43,361 acre-feet in the 20-year period since 1987, when it was impounded. Consequently, enough sediment has accumulated during that 20-year period to cover the bottom of the 43,384-acre reservoir to an average depth of one foot (Figure 6). Texas A&M University researchers estimate that 84% of the sediment reaching the reservoir every year is from channel and stream bank erosion (Wang et al. 2010).

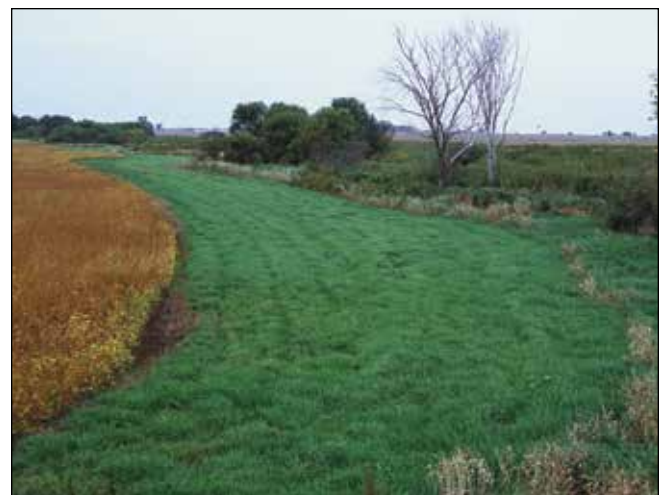
Figure 7. Riparian buffers protect creeks by reducing water velocities and capturing sediment from croplands. Photo courtesy of USDA – Natural Resources Conservation Service.

A riparian buffer is defined as a vegetated strip lying between agricultural land and a neighboring watercourse (Figure 7; Collins et al. 2009). Studies indicate that riparian buffers are an effective best management practice (BMP) for reducing nonpoint source pollution (NPS) in agricultural areas. These buffers and other agricultural BMPs can help prevent and/or minimize the effects of NPS by reducing erosion and pollutant loads that would otherwise reach the stream. In some cases, riparian buffers of only 32 feet in width can reduce phosphorus levels up to 95% (Vought et al. 1995), and nitrate levels up to 80% on row crop fields (Schultz et al. 1995). In addition, buffers as narrow as 20 feet can prevent up to 95% of the sediment eroded from uplands from reaching streams (Collins et al. 2009). Likewise, riparian buffers can benefit wildlife populations by providing corridors that connect habitats and allow safe movement between fragmented

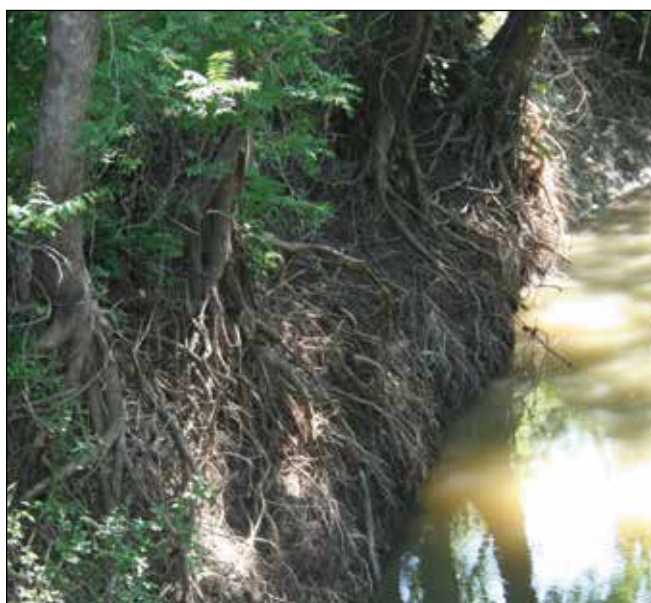
Figure 9. Tree roots armor this bank and help to reduce erosion by protecting the soil from water flow. Photo by Blake Alldredge, Texas A&M AgriLife Extension Service.

to increase channel stability in three primary ways: mechanical reinforcement due to tree root tensile strength, decreased moisture content resulting from evapotranspiration of soil moisture through tree leaves, and bank armoring against channel scour by exposed tree roots (Figure 9).

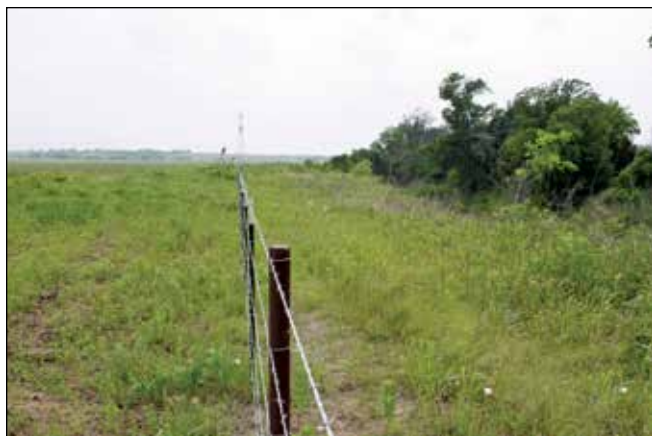
Figure 12. This riparian fence could be moved back 200 to 300 yards to create a riparian pasture. Photo by Blake Alldredge, Texas A&M AgriLife Extension Service.

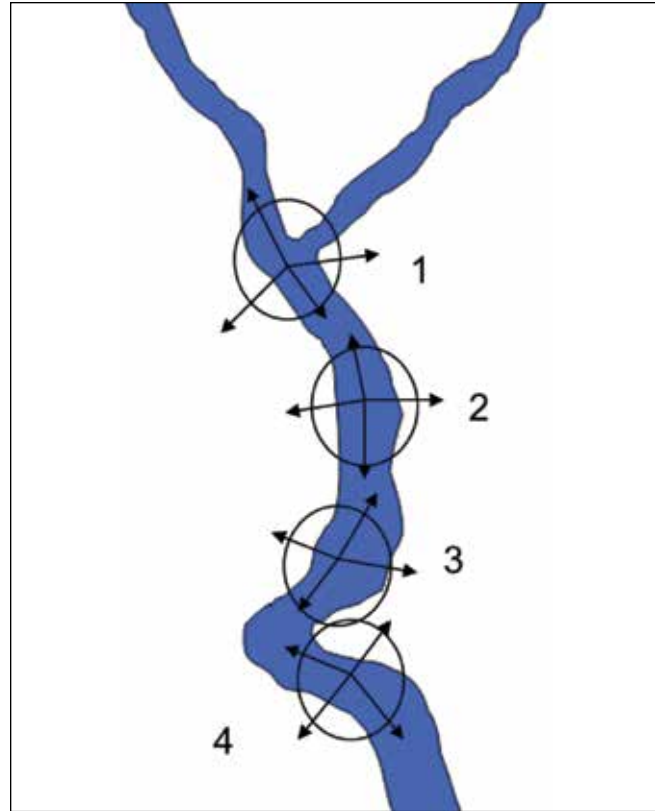
Figure 16. Physical locations for photo point monitoring stream-riparian areas should be located on either bank. Arrows show the direction of photographs. Illustration by Dr. Larry White (retired) and Nikki Dictson, Texas A&M AgriLife Extension Service.

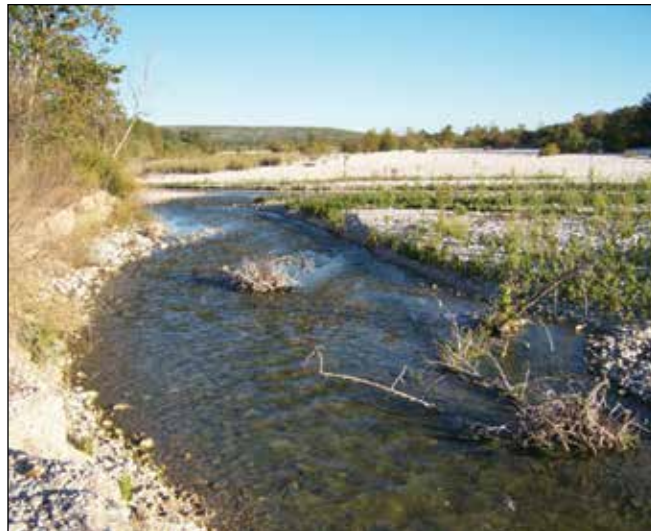
Appendix B. Example of photo point monitoring along the Nueces River after the prohibition of off-road vehicles in the riverbed. Photos by Sky Lewey, Nueces River Authority.
