RIPARIAN AREA MANAGEMENT

Proper Functioning Condition Assessment for Lotic Areas

Technical Reference 1737-15
Second Edition
2015

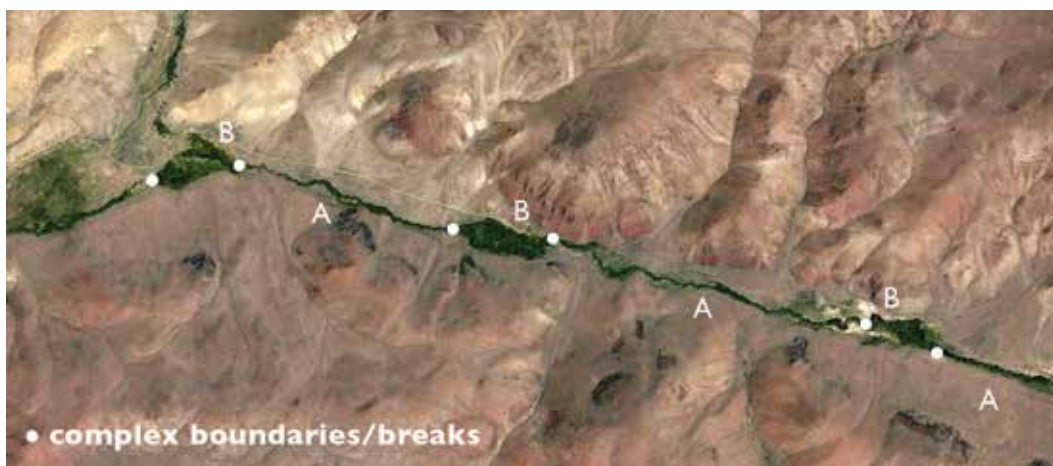
Figure 5. Alternating lotic complexes within a valley segment reflect the influence tributary fans have on the main stream valley. Where fans are wide and dominate the valley floor, the riparian corridor is “pinched” and narrow (complex A). Upstream of fans, the valley bottom is locally flattened, allowing a broader expression of riparian communities (complex B). Streamflow is from right to left. (Image obtained from Esri World Image Service. World_Imagery - Source: Esri, i-cubed, USDA, USGS, AEX, GeoEye, Getmapping, AeroGRID, IGN, IGP, and the GIS User Community.)

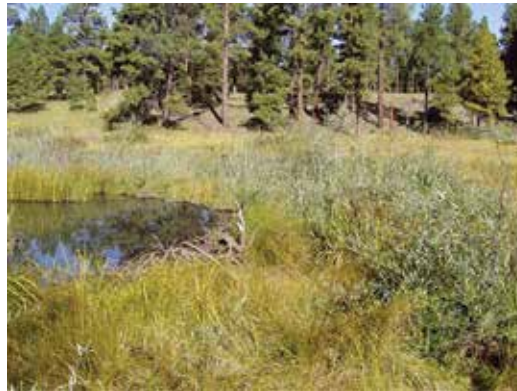
Figure 10. A very stable beaver dam covered with a thick growth of herbaceous and woody vegetation.

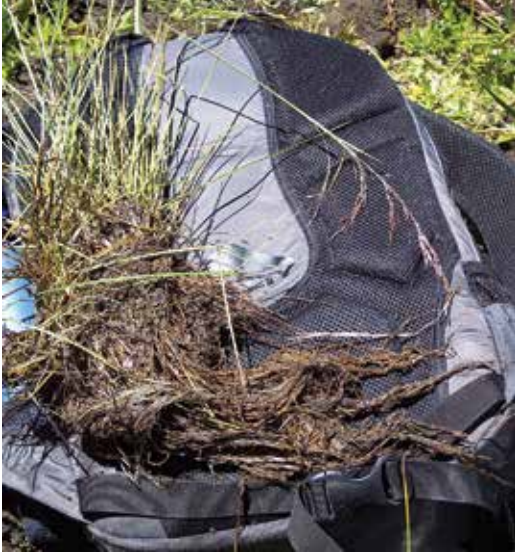
Figure 23. Stabilizing vegetation exhibits highly developed root structures.

Riparian species, such as willow, alder, aspen, birch, and cottonwood, or deep-rooted herbaceous species, such as sedges, rushes, bulrush, and some riparian grasses, have root masses capable of withstanding moderately high-flow events (figure 23). If these plants have formed recognizable communities along a streambank or developing banks (such as point bars) of a degraded stream, the answer to item 9 would be “yes.” For some intermittent systems (and some perennial systems as noted above), the presence of recognizable communities of facultative plants may be all that is required for a “yes” answer, as this may be all these systems can produce.

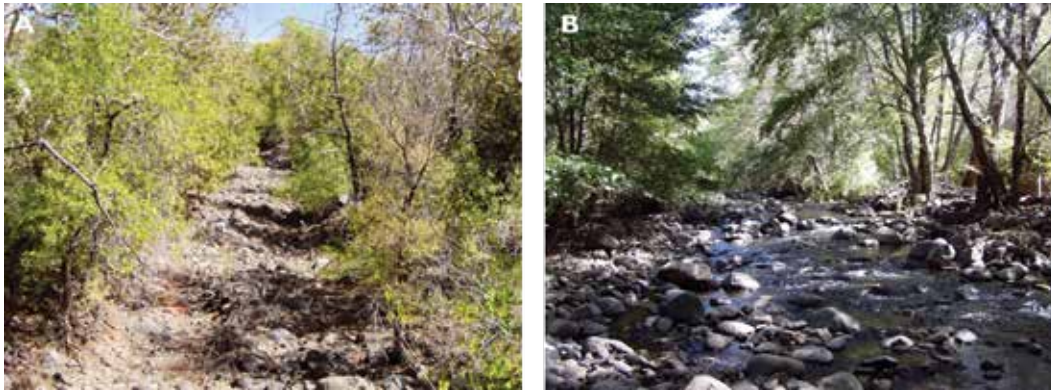
Figure 26. Overflow channel (A) adjacent to the stream (B). The overflow channel is providing for energy dissipation from both its position on the floodplain and the roughness contributed from the adjacent riparian vegetation.

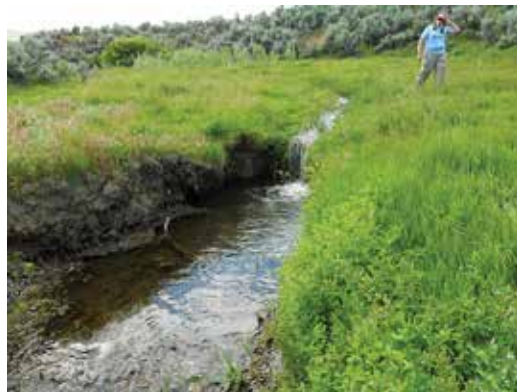
Figure 37. A headcut is moving upstream through a meadow, making the riparian area upstream of the headcut functional-at risk.

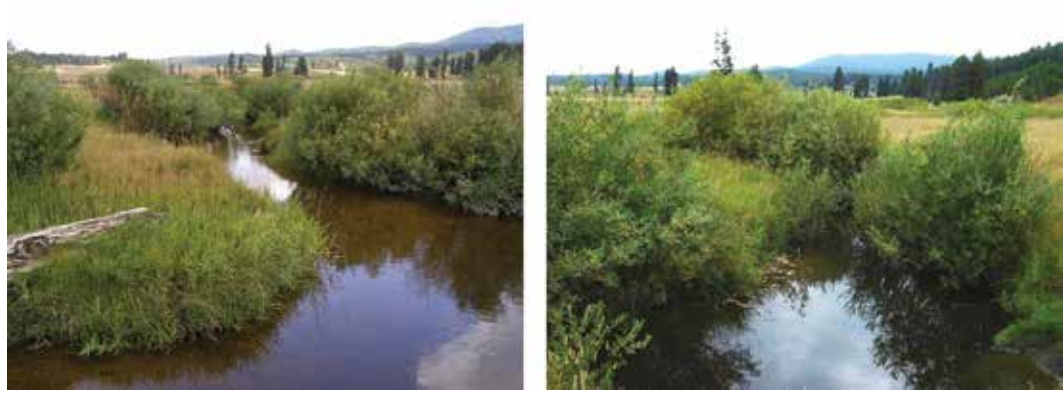
Reach 1: Proper functioning condition

Rating and Key Factors: Reach 1 is rated as PFC because all assessment items were answered “yes” and the reach has adequate vegetation to dissipate energy and meet the comprehensive definition of PFC. Not only is this reach in PFC, it is very near potential. This reach has clearly recovered from the past channel incision as willows and other riparian stabilizers have become reestablished and the channel has narrowed. The channel has adequate floodplain connectivity, the channel shape is appropriate for the landscape setting, and multiple species and age classes of vigorous riparian stabilizers are present. Although there is some streambank instability present on some outside meander bends in the form of slump blocks, it is limited in extent. It is not uncommon for streams to exhibit some streambank instability at PFC or even at potential.

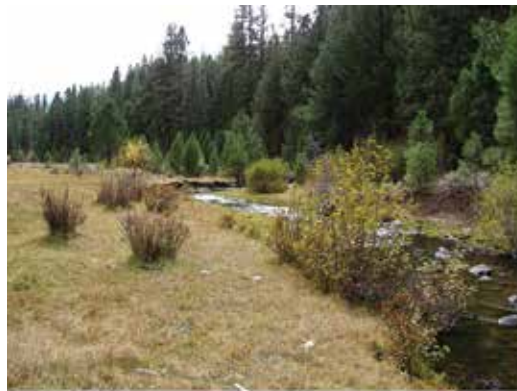
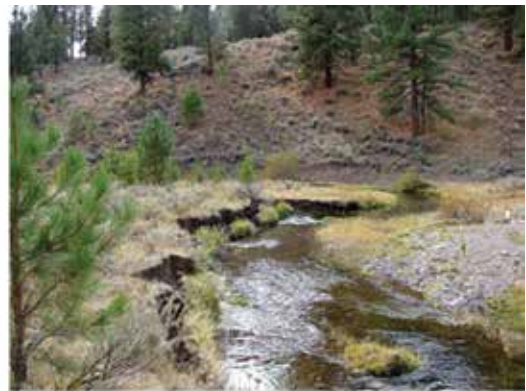
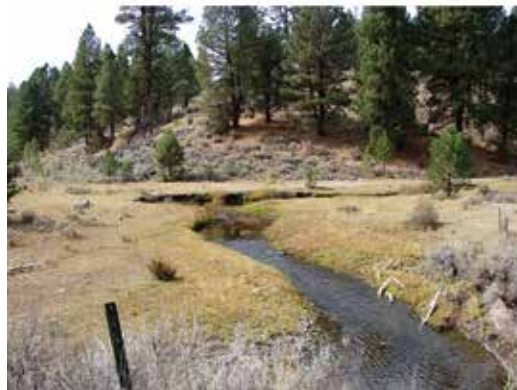
Rating and Key Factors: This stream reach is rated FAR with a downward trend because of the overwidened, dish-shaped channel and bank instability caused by a lack of stabilizing riparian vegetation (estimated at only 20 percent cover). Herbaceous stabilizers show little or no recruitment of young plants. There are multiple age classes of alder, but young shrubs and trees show evidence of repeated browsing as indicated by a “clubbed” growth form. Point bars are not vegetating. Without a well-vegetated riparian area to attenuate streamflow, excessive erosion of streambanks continues at most meander bends. The riparian area has the species composition that would support recovery under changed management.

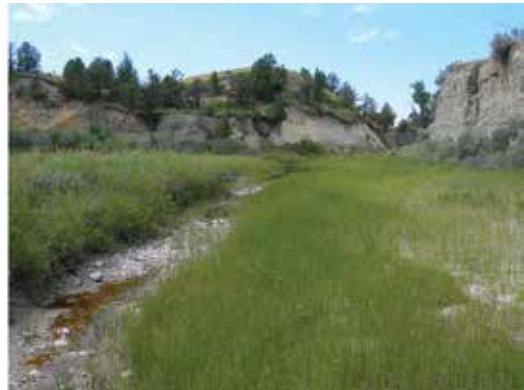
Photo 2b. A reference site shows a comparatively narrow, deep channel. A common threesquare bulrush (*Schoenoplectus pungens*) community dominates the right bank and floodplain.
