2% SOLUTIONS FOR HUNGER, THIRST AND CO₂

no. 9/July 2013

Thinking Like a Creek

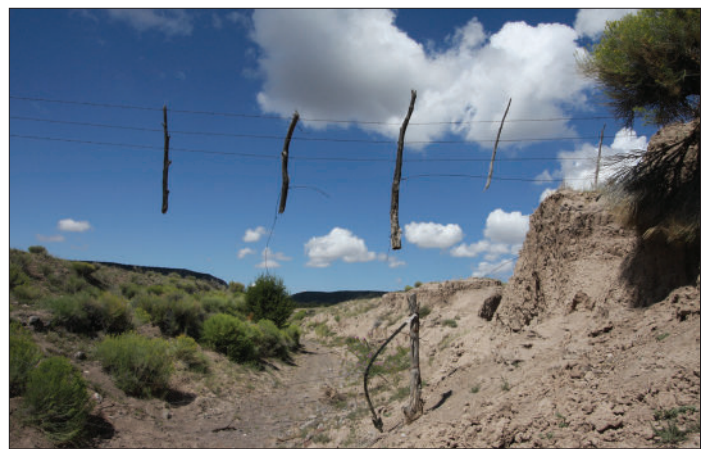
These fence posts rested on the ground in 1937. © Courtney White

Over the years, Bill has developed a very effective set of low-cost techniques that reduce erosion, return degraded riparian areas to a properly functioning condition and restore wet meadows. This is important because a big part of the West exists in an eroded condition, generally the result of historically poor land management. This point was brought home to me in force one day when I walked under a barbed wire fence that stretched across a gully on a New Mexico ranch. The fence was five feet above my head. The rancher told me that the fence was built in 1937 and the fence posts originally rested on the ground!
